HISTORIC STRUCTURES REPORT

BRICK WALKS

WILLIAM HOWARD TAFT NATIONAL HISTORIC SITE

Mark A. Chavez, Regional Historical Architect

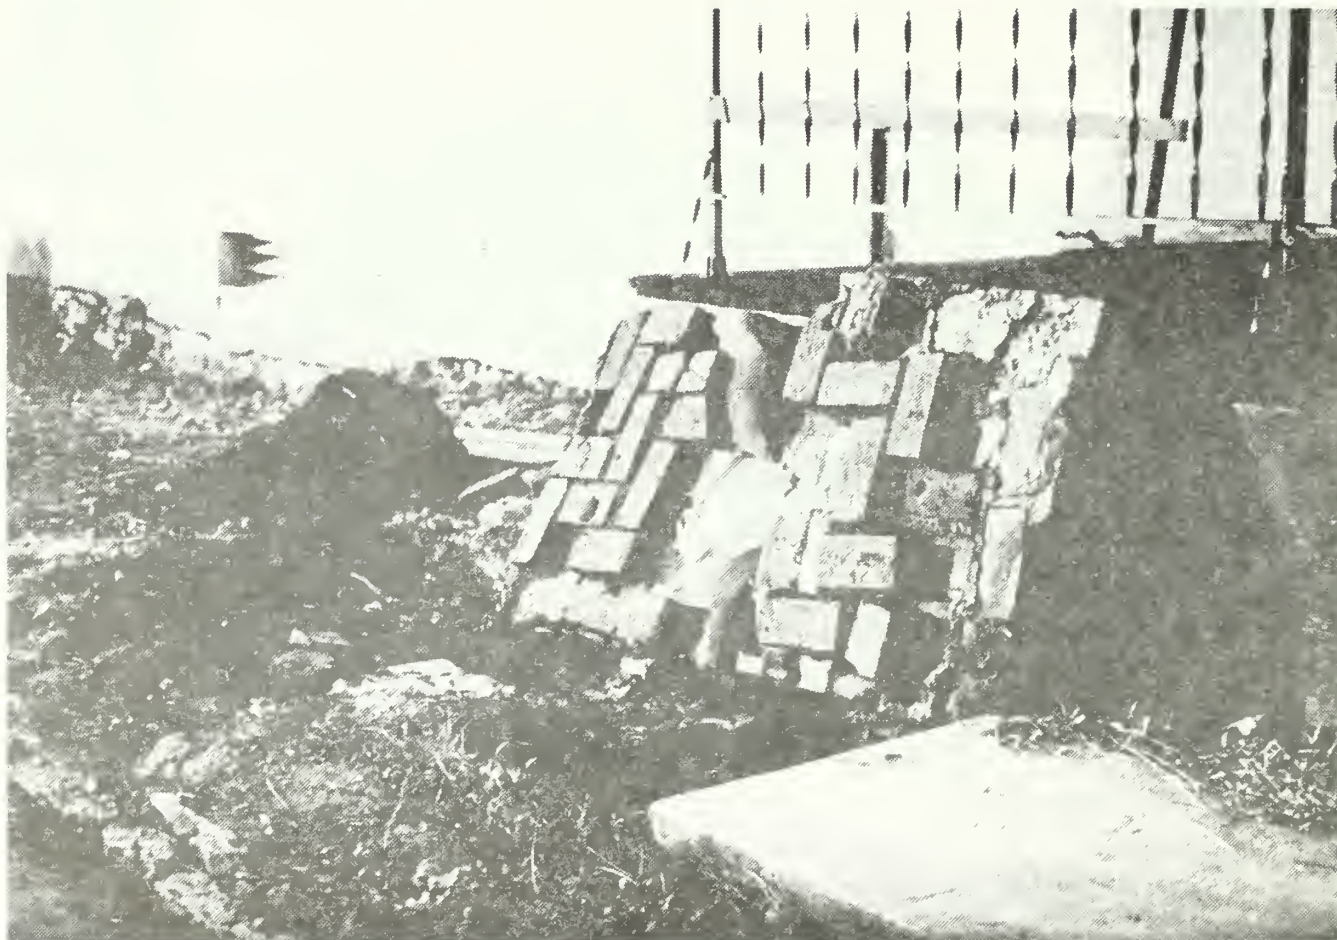
FIGURE 3.8

Both layers of brick, according to Perry's analysis, were of a much later (early 1900s) variety than those attributed to the Taft occupation. Historic pavers were not located beneath the two non-historic layers. Also, the historic walk would have been closer to the house (two feet, versus six feet as existed in this photograph).

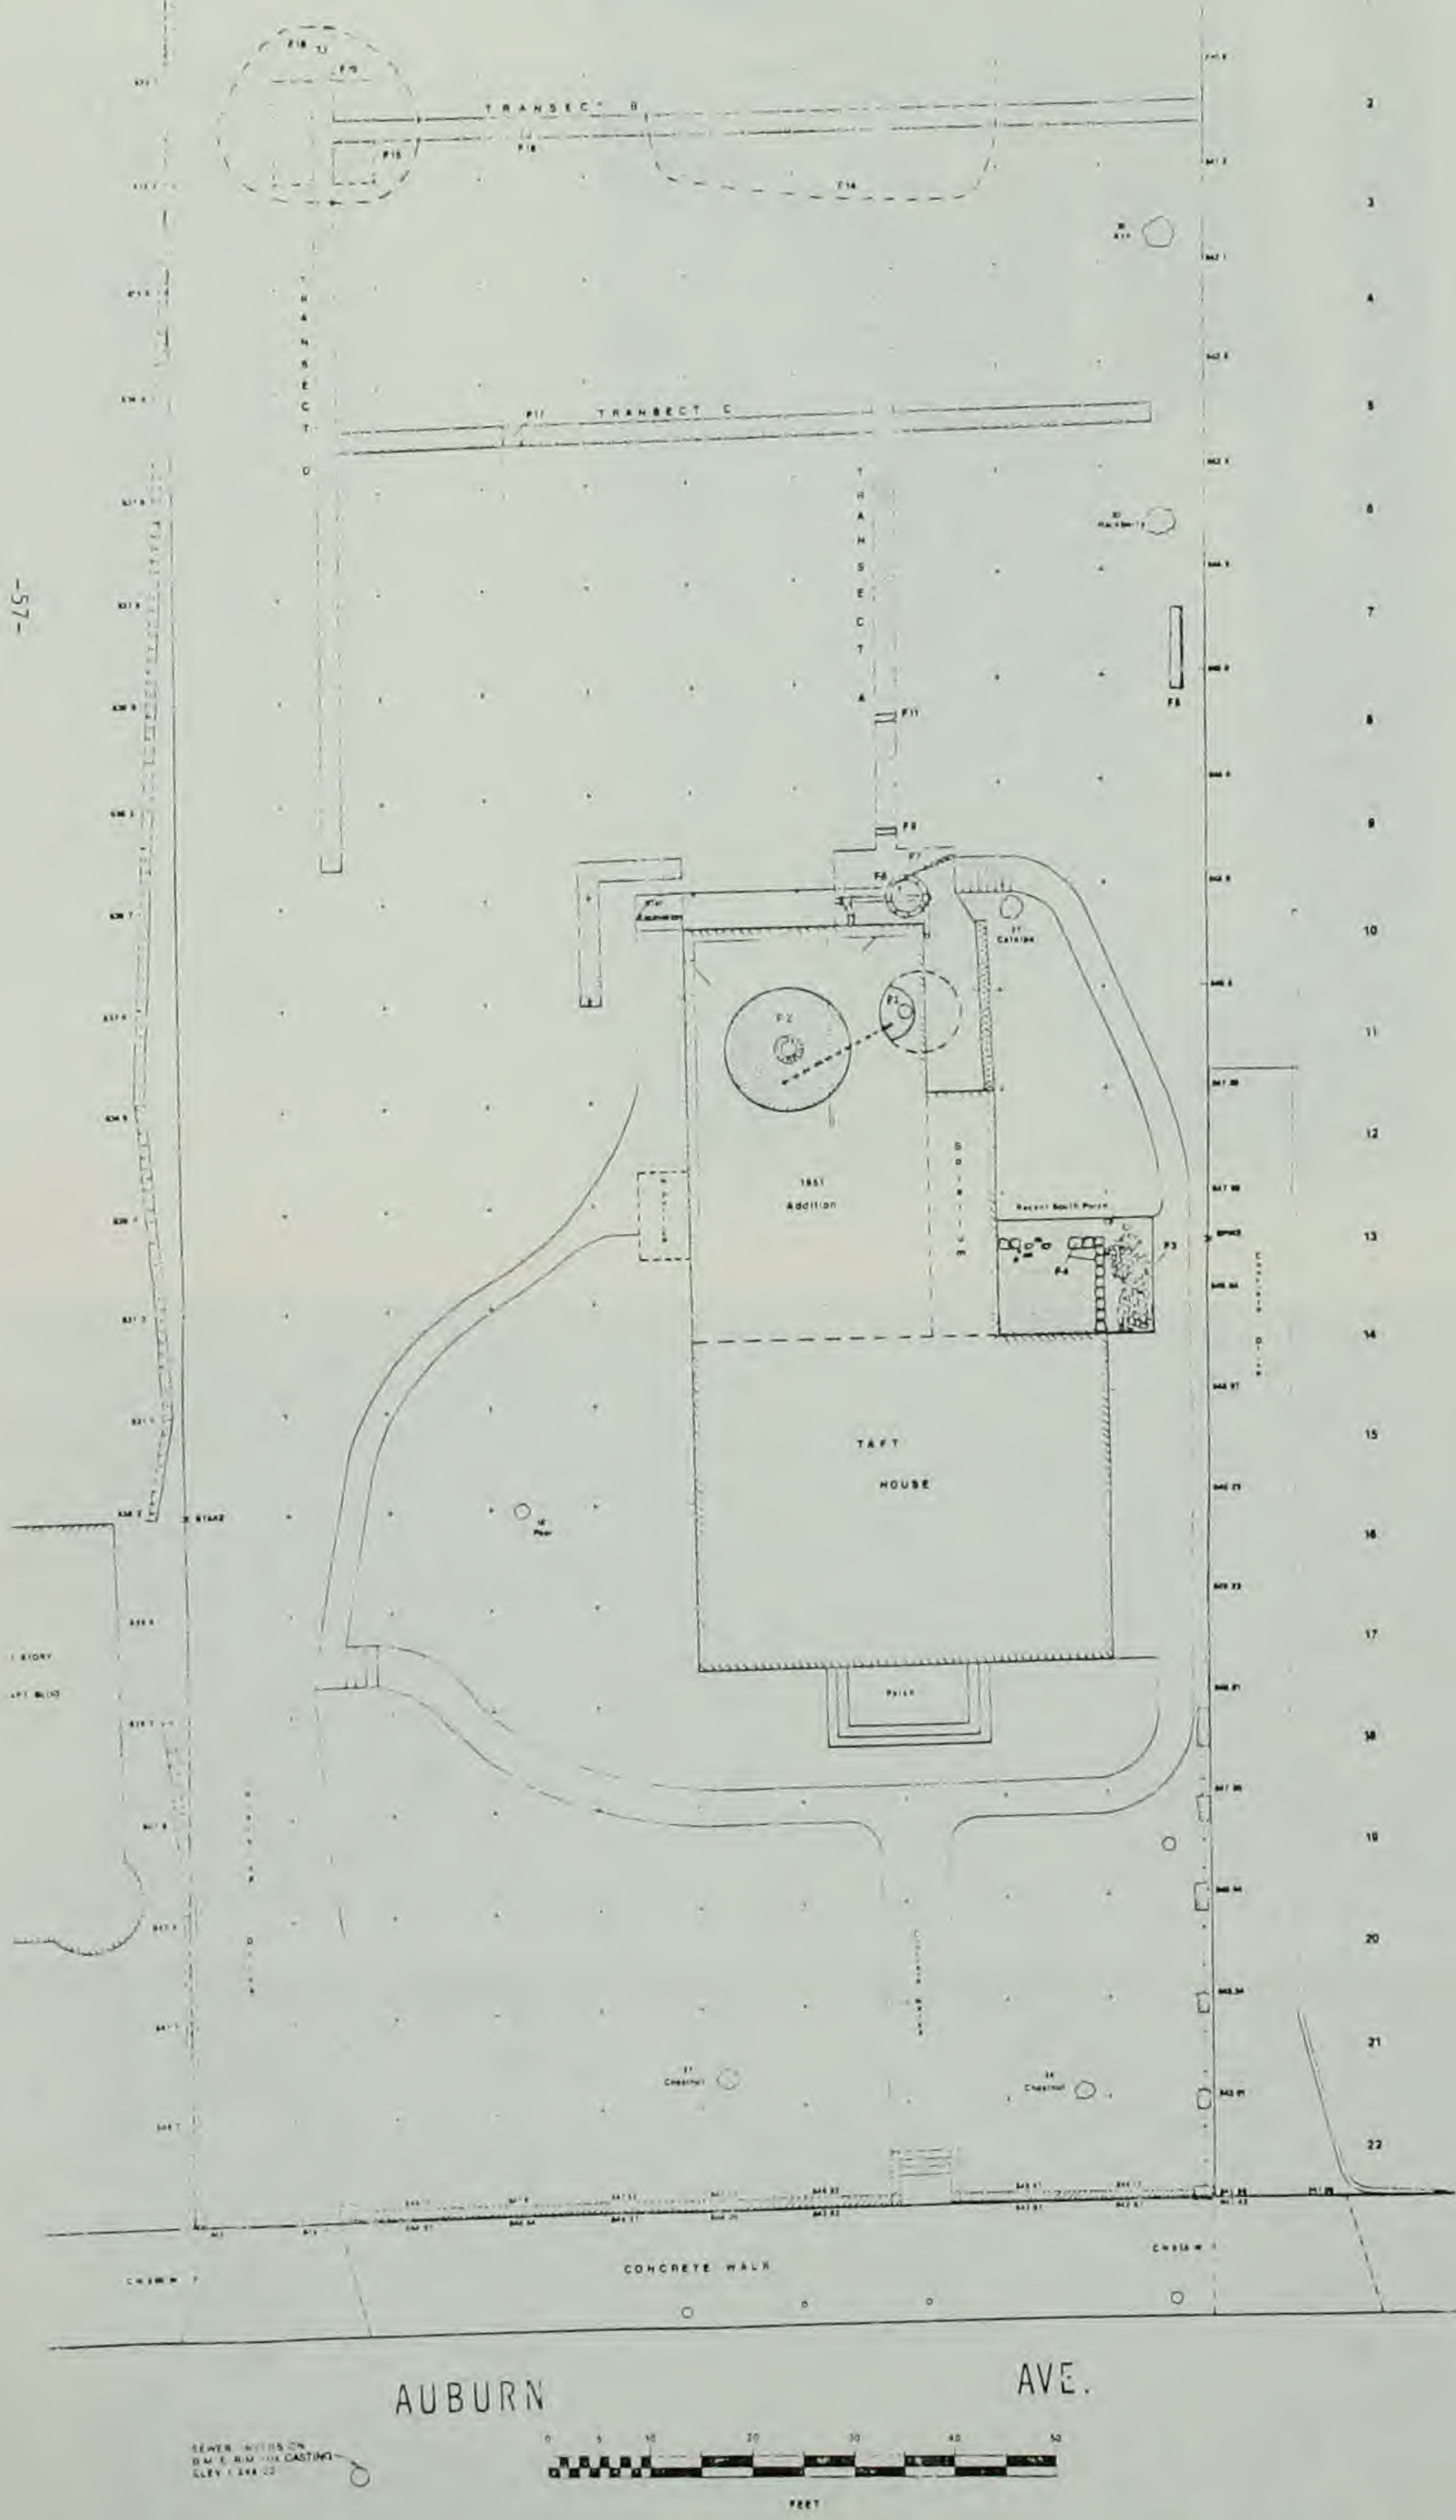
FIGURE 3.10 SITE PLAN OF ARCHEOLOGICAL FEATURES (McCollough 1972)

The first test for the walk was placed just off the Northeast corner of the house and consisted of two intersecting perpendicular trenches, each two feet wide and ten feet in length (Fig. 1) [see Figure 3.10]. Mr. Paul V. Kiel's tests of foundations and downspouts had disturbed the area abutting the corner of the building (incidentally revealing that the cement sidewalk at this corner was poured over an earlier herringbone-patterned brick walkway), and the 1971 trenches were accordingly centered at distances of six and nine feet from the east and North walls of the house, respectively; this configuration of trenches was designed to transect the path of a walkway which might have led westward from the corner of the building or the area in front of a "kitchen" door in the rear of the North wall. The results of the test were negative in that no such

The truncated remains of herringbone-patterned brick paving (Feature #7) [see Figure 3.10] shown on a ca. 1920 photograph (McCollough 1971: Plate VIII) [see Figure 3.1] were found at the eastern edge of the cement sidewalk (Plates XVII and XVIII) [see Figures 3.12 and 3.13, respectively], incorporated in the base of the Level II humus and resting directly on the surface of

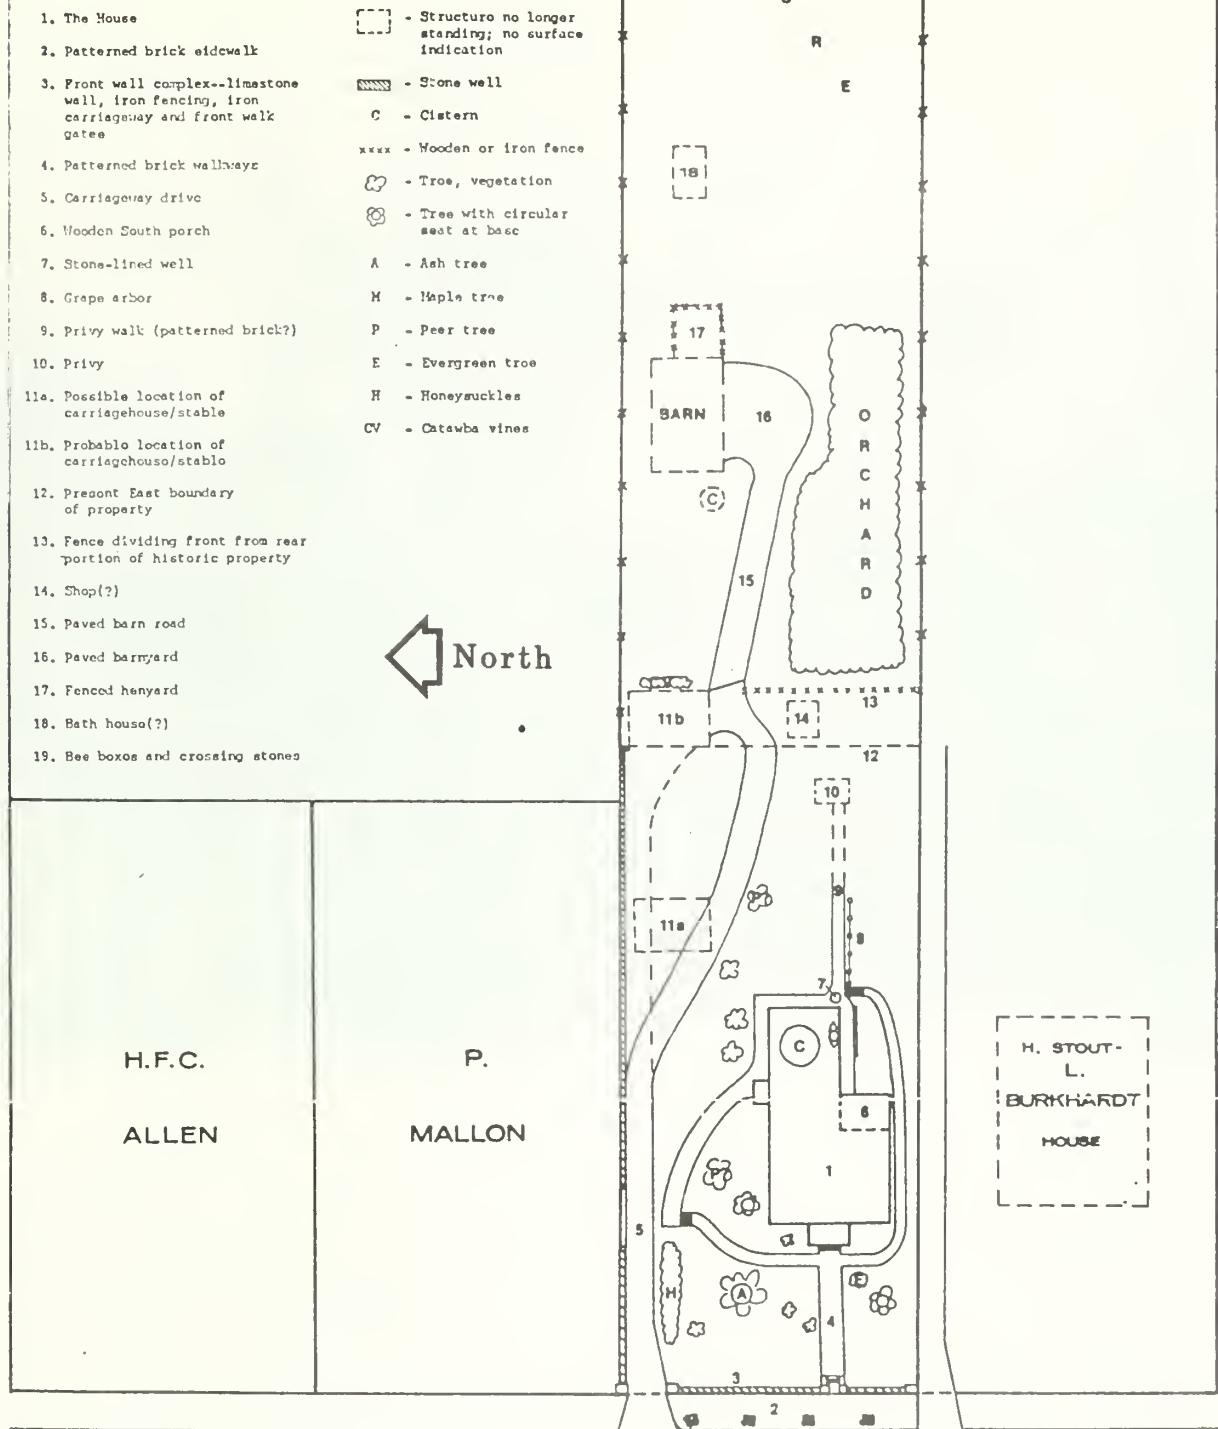
FIGURE 3.17

Northwest Sidewalk: A further reexamination of the historic photograph, approximately 1868 [see Figure 3.9], showing the Taft Family, raises some question in this author's mind as to the existence of a sidewalk illustrated on the McCollough drawing [see Figure 3.17], extending from the northwest corner of the front porch on the west facade of the 1819 [sic: 1840] wing. Sidewalk mentioned extended northward to approximately the northwest corner of the wing and then curves slightly eastward once again turning northward to a set of steps which in turn descended to a walk connecting the historic north entrance ["carriage entrance"] on the 1851 wing. There does not seem to be the conclusive evidence in the subject photograph to justify the assumption that this walk existed.

The McCollough drawing [see Figure 3.17] indicates a walk pattern extending from the historic north porch in a curvilinear manner, heading northward and westward to a point terminating with the earlier discussed front

Using the above calculations, it is difficult to imagine how 1300 bricks could have been used to pave "behind and north and south of the house," since, to pave these areas (walks 2, 3, 4, and 7)--according to the above calculations--approximately 3780 brick would have been needed. Also, according to the above, the front walk would have required approximately 1355 brick, which is very close to the quantity listed (1300) which was said to have "finished paving the front walk."

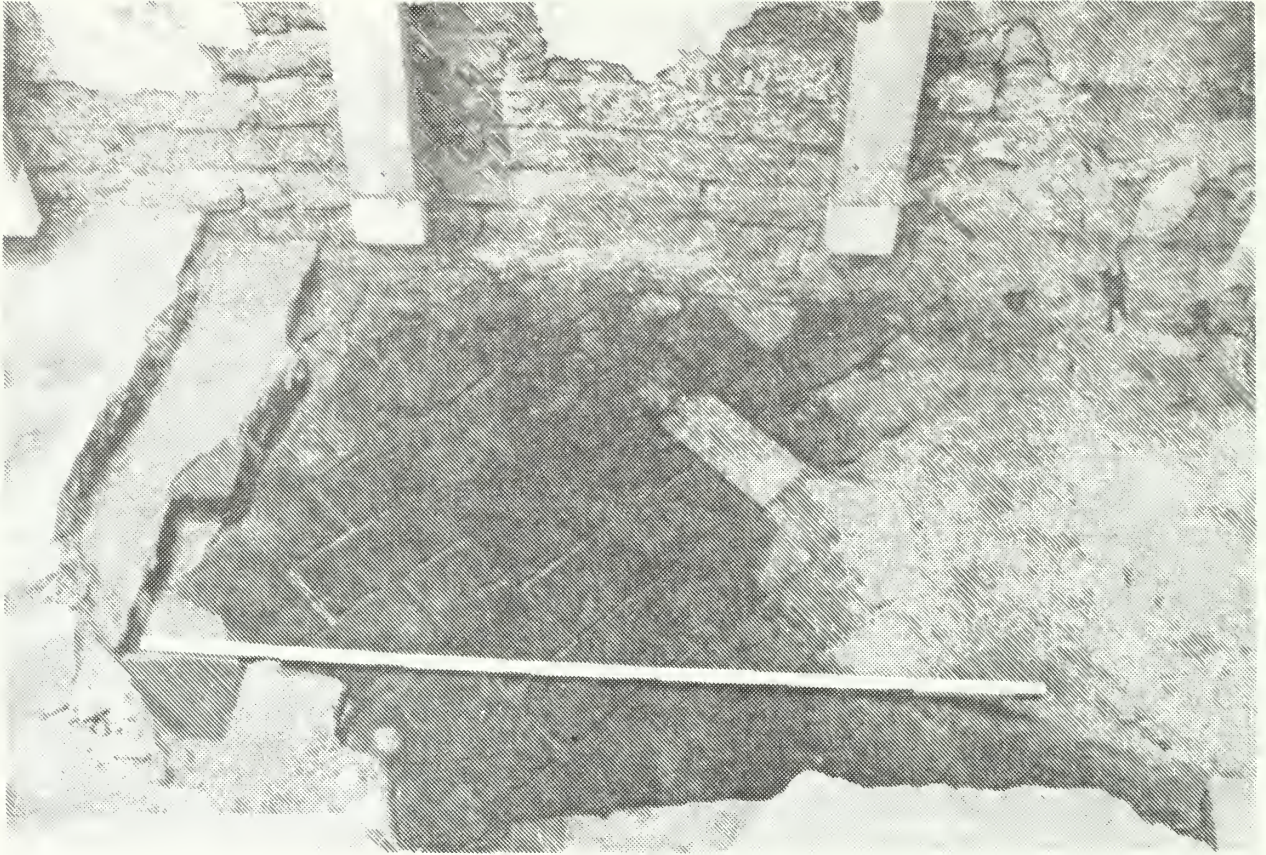
FIGURE 3.22

B) Beneath the paving shown at "A" was a layer of historic paving, similar to the section which is seen about six feet north of the east door. Note that there would have been at least one step down from this door to the walkway. Figure 3.22 is a detail of this area.

Concrete walks in this area, when removed, revealed a layer of vitreous brick pavers beneath. Under these pavers was a layer of paving similar to what is seen in this photograph. The brick type matches Perry's analysis of historic paving, as does the method of construction (dry-laid in sand) and the pattern (diagonal herringbone).

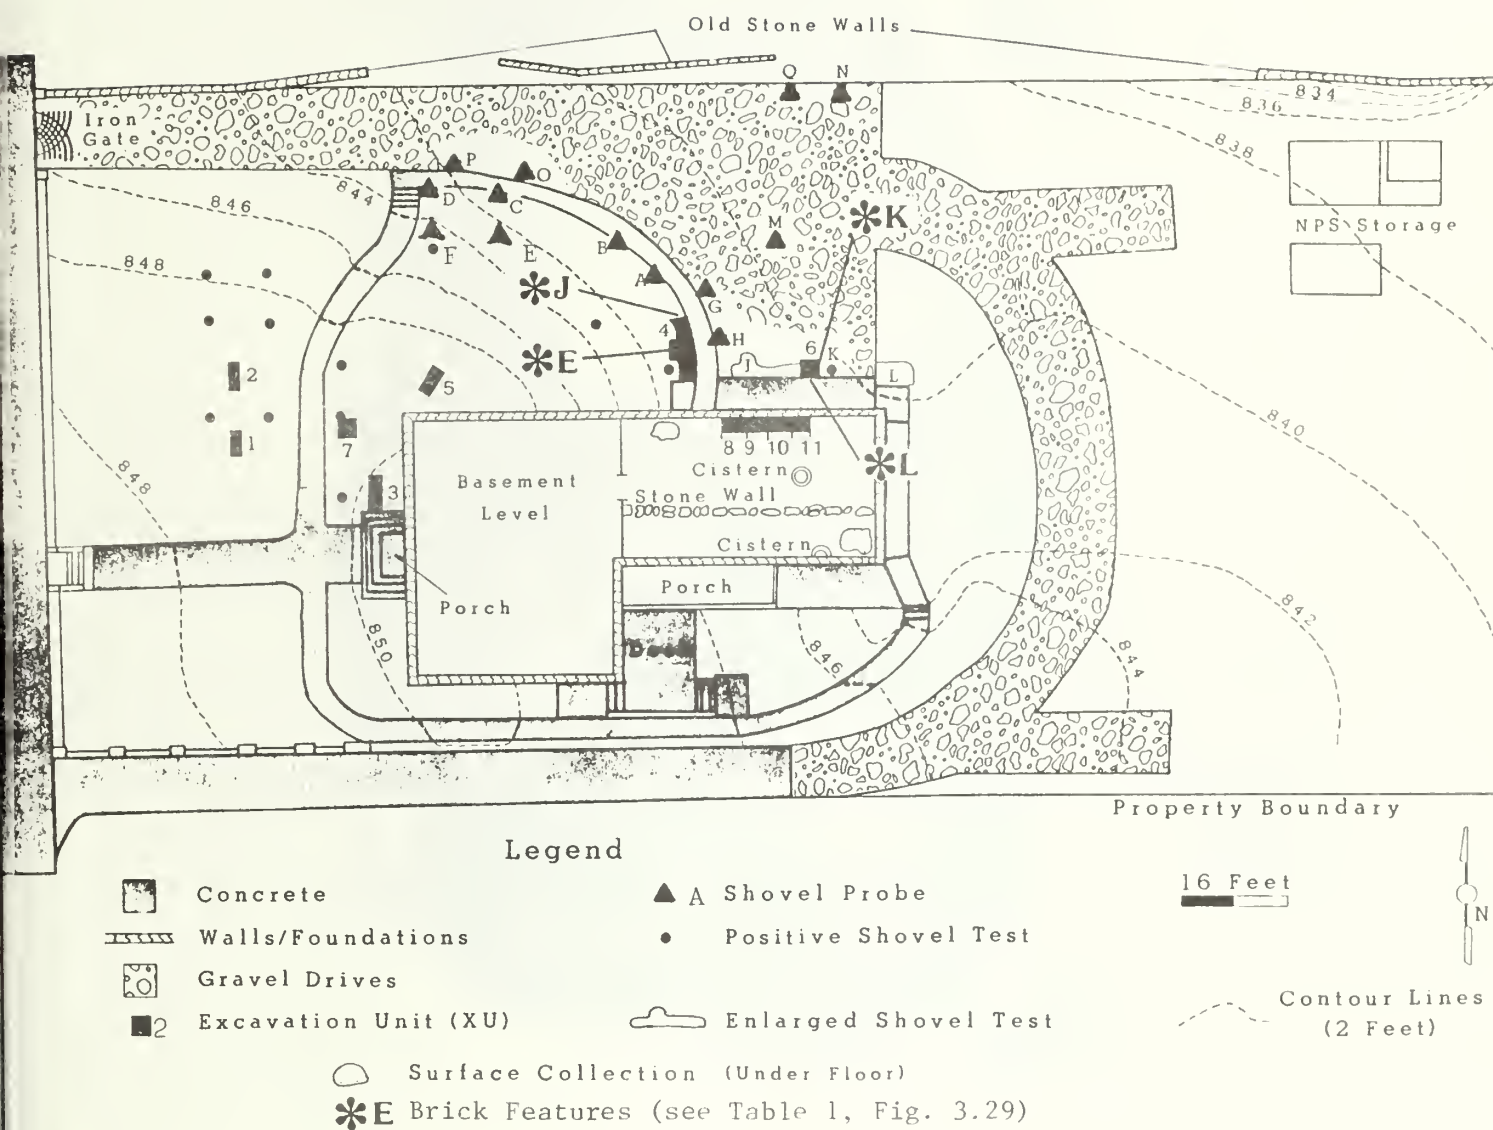
FIGURE 3.24

North Yard/Carriage Entrance Area: The brickwalk (Feature K) [See Figures 3.24 and 3.29] extending from XU 4 dates from the turn- of-the-century or later (i.e., it is non-historic).

Evidence in support of this contention comes indirectly from historical and archeological documentation. The brickwork consists of MCMANIGAL paver bricks set into cement and constitutes one of four different brickwork patterns observed on the site. This contrasts brickwork associated with the Taft occupation which is characterized by common brick set in sand (Bauxar 1975; McCollough 1972). In addition, the MCMANIGAL bricks are very similar in manufacture to the Carlyle bricks observed in the north retaining wall. These bricks have been tentatively dated as being produced sometime between 1907 and 1928 (Conrad Weitzal, personal communication 1982). Lastly, stratigraphic profiles in Shovel Probes G and H [see Figure 3.24] indicate that Feature K overlies at least two previous surfaces of the carriage drive. Combined, the historical and archeological information generally supports the view that the MCMANIGAL walk (and the contemporary cement walk overlying it) post-date the 1900s, and may not trace exact paths used during the Taft period.

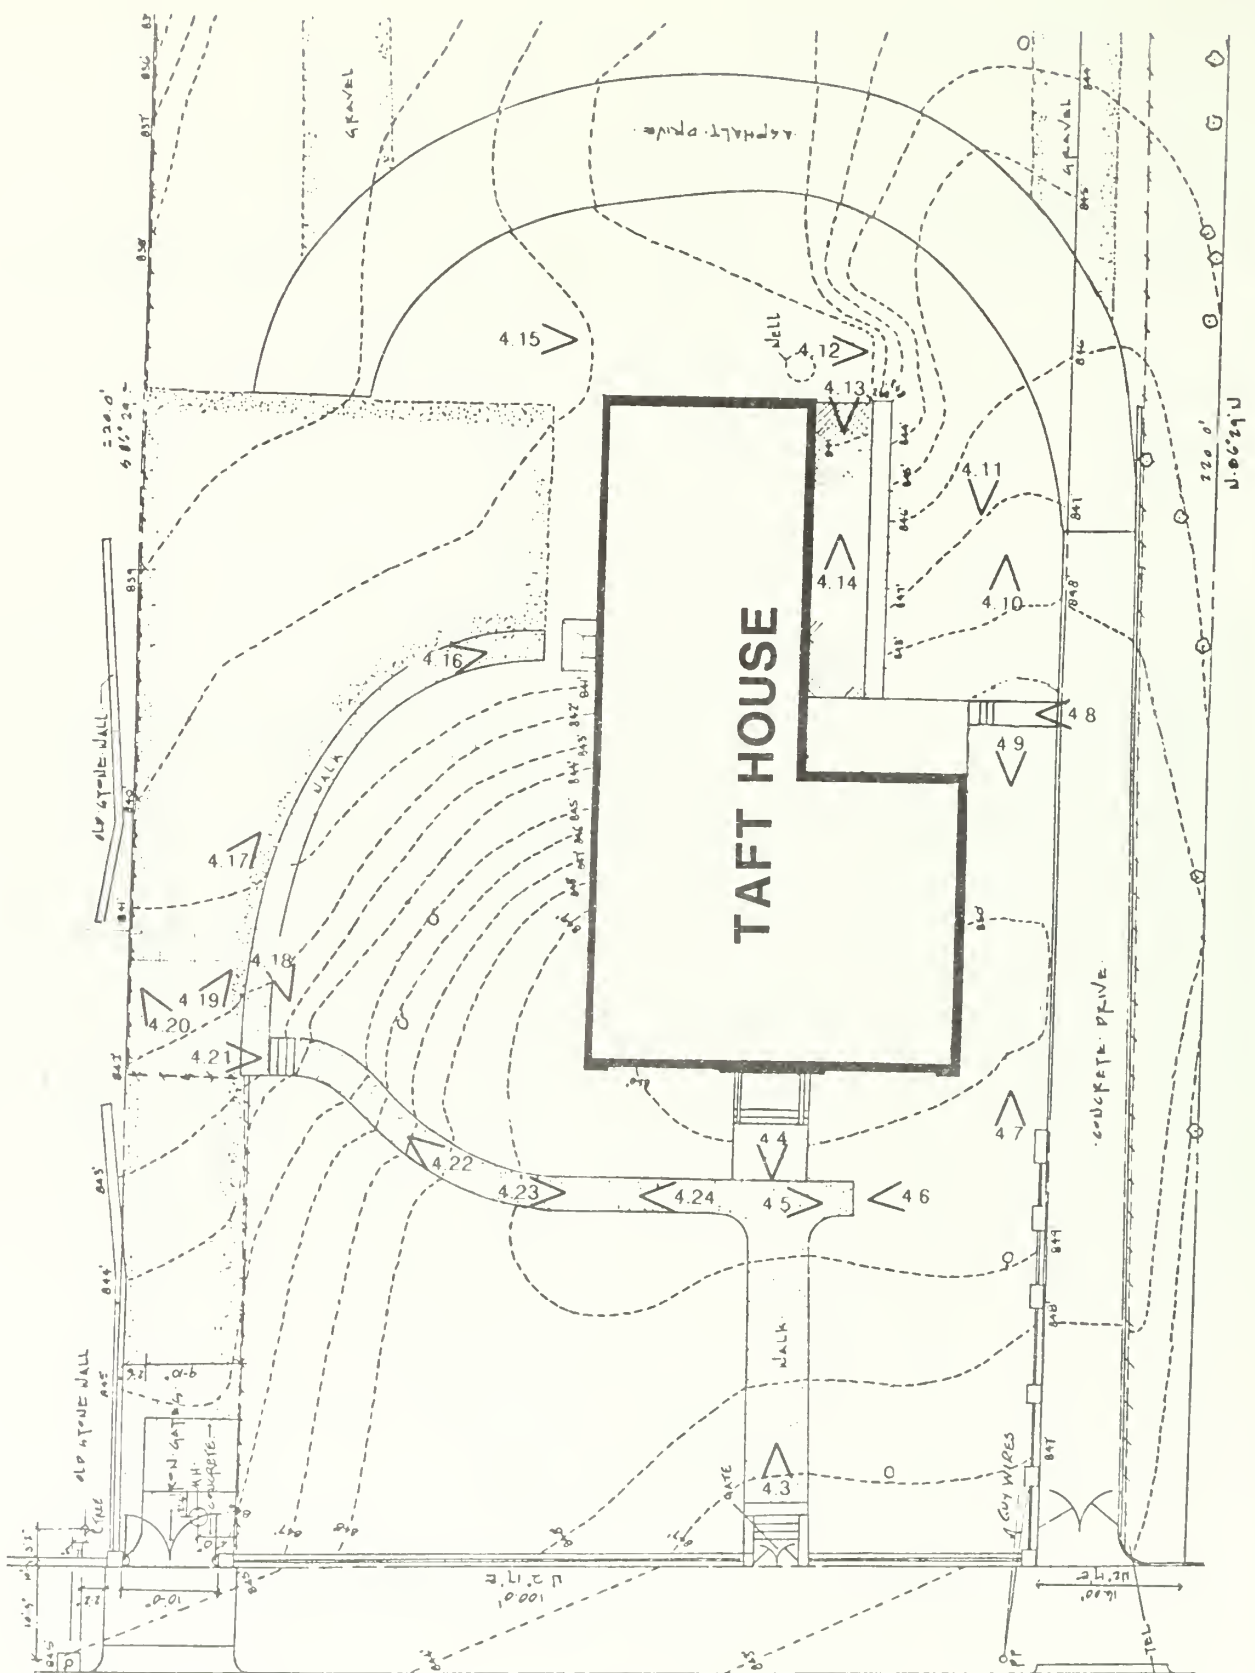
FIGURE 4.2

Existing Conditions Site Plan (1987)

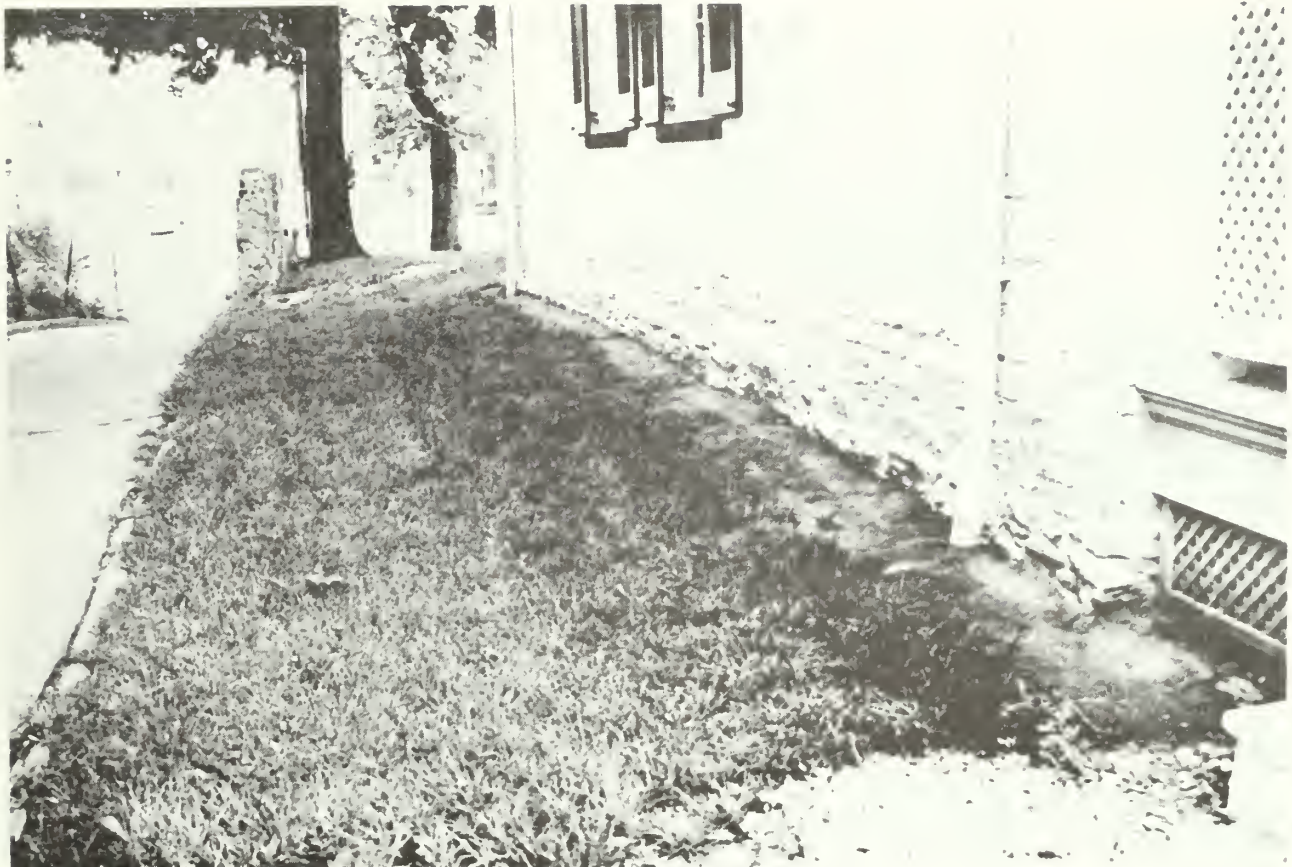
FIGURE 4.9

The historic brick walk was located approximately 2-feet from the south exterior wall of the house.

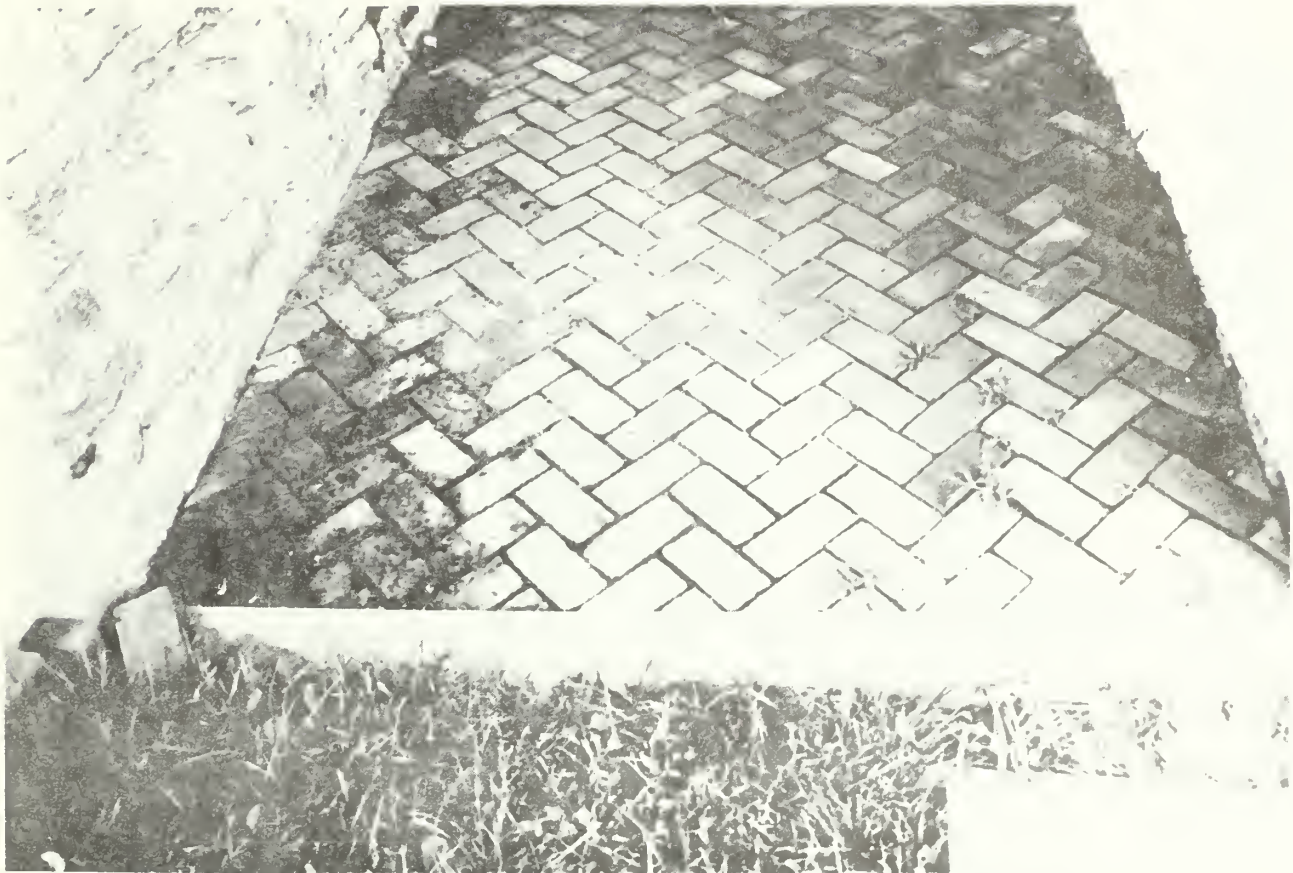
FIGURE 4.13

Grounds of Taft Home (detail of the reconstructed "areaway" paving at southeast corner of house).

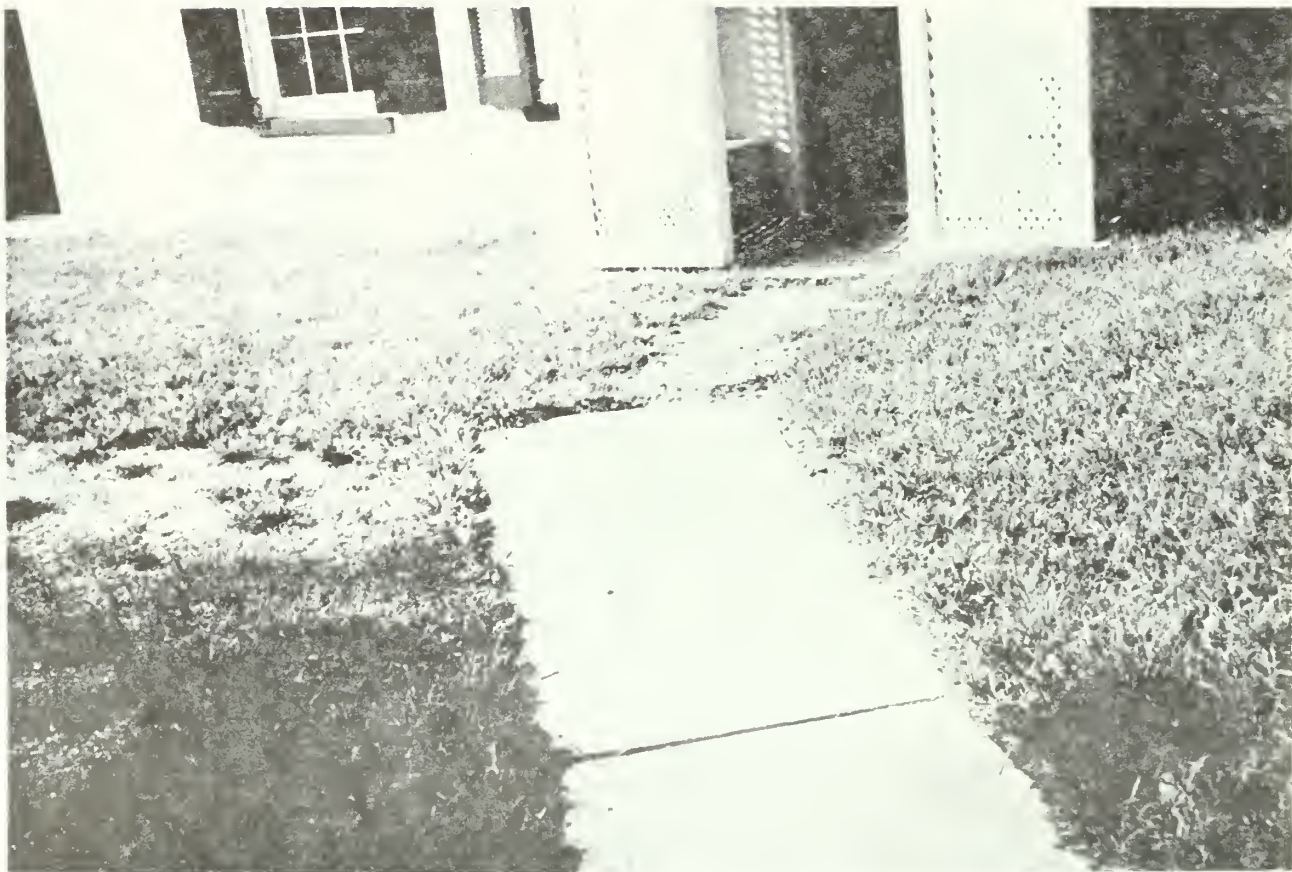
FIGURE 4.16

Grounds of Taft Home (looking south at termination of contemporary concrete walk near carriage entrance).

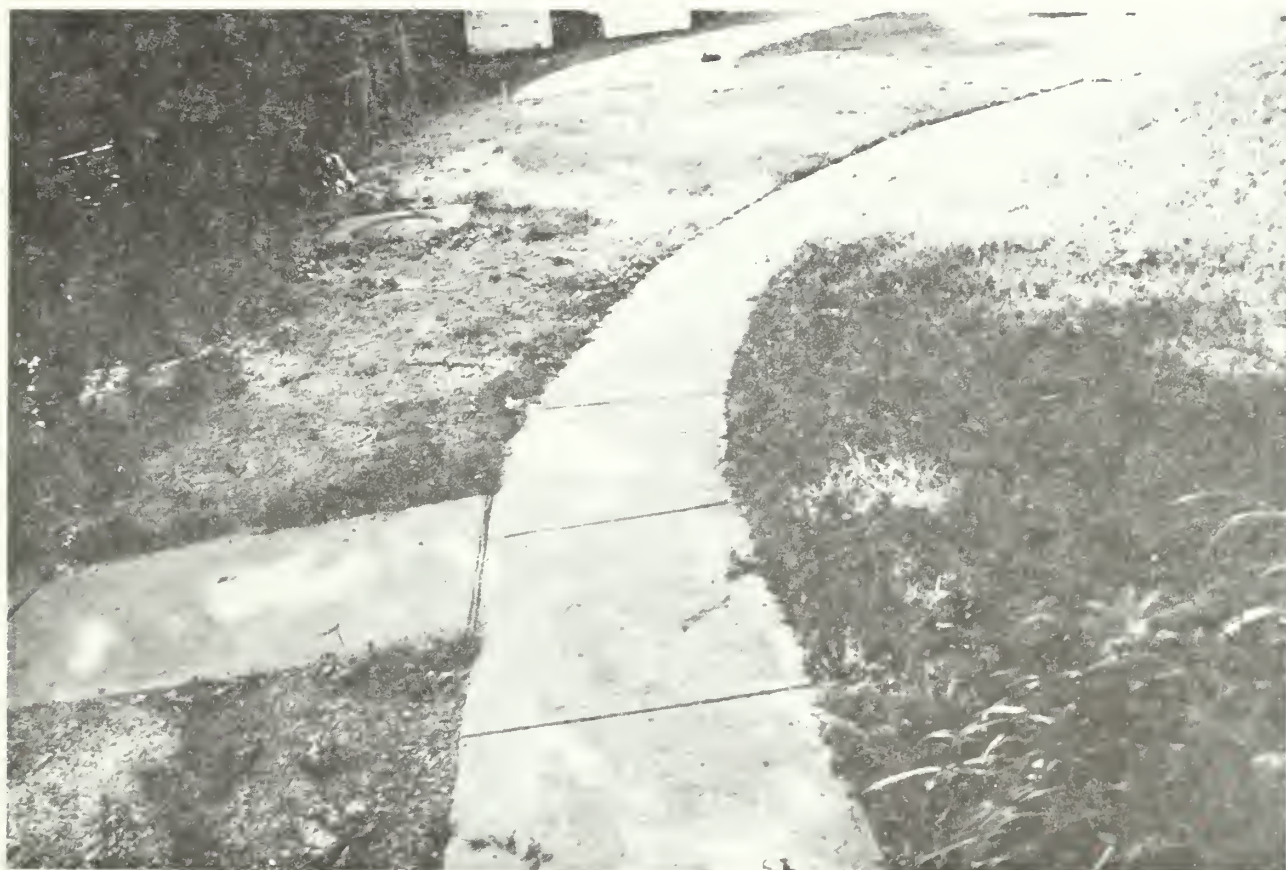
FIGURE 4.19

Grounds of Taft Home (looking east along existing concrete walk leading to carriage entrance).
